NEW HAMPSHIRE  
AGRICULTURAL EXPERIMENT STATION  
Department of Entomology

STUDIES IN  
TERMITE CONTROL

By W. C. O'KANE and W. A. OSGOOD

NEW HAMPSHIRE COLLEGE  
OF  
AGRICULTURE AND THE MECHANIC ARTS  
DURHAM, N. H.

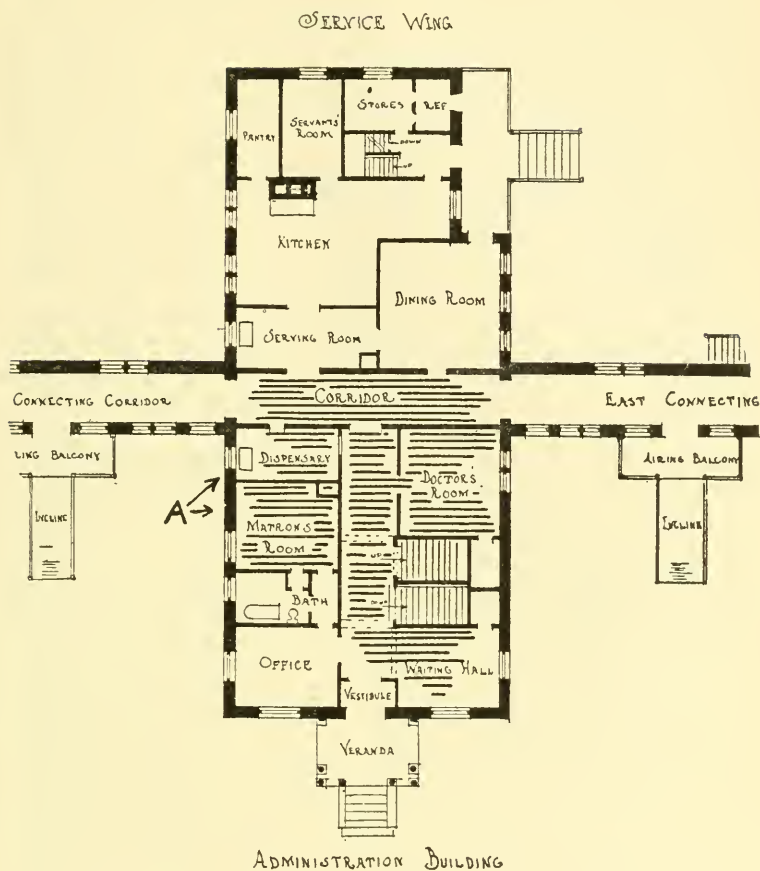
FIG. 1. Plan of the first floor of the administration building. The infestation on this floor extended through the area shaded in horizontal lines.

but has since been made a part of the matron's room. (Fig. 1, A). The emergence lasted for only a short time. While it caused anxiety to the hospital staff, nothing further was seen of the insects on that occasion and it was supposed that they were no longer present.

the basement were carefully examined for possible cracks and throughout the entire season a close watch was kept for any possible entry of termites through the walls. In no case were they discovered. The areas on the first floor where flooring was removed and replaced are indicated by the shaded portion shown in Fig. 1.

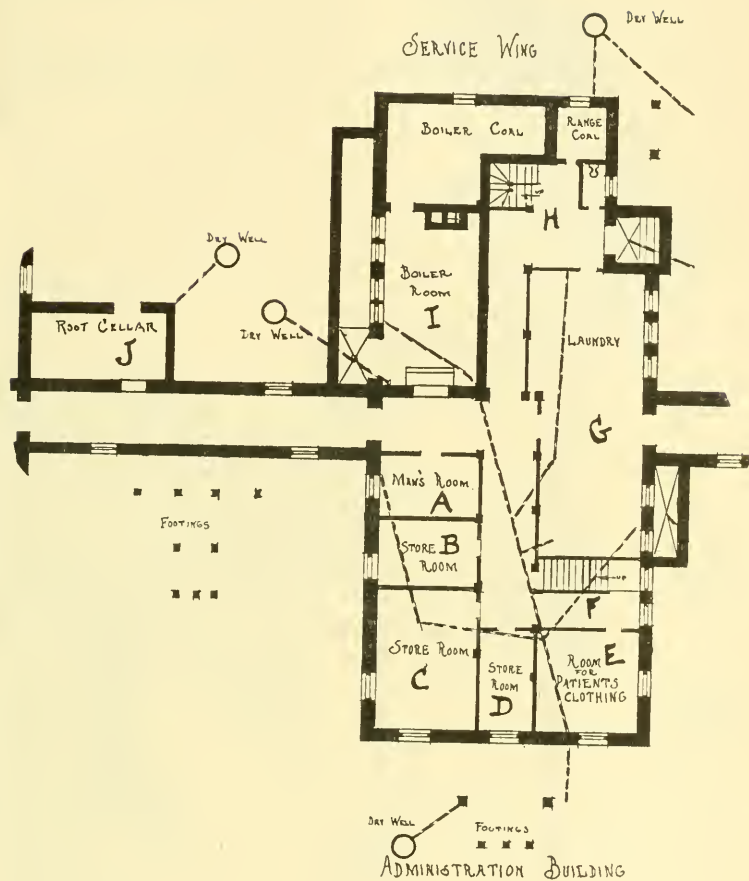
## BASEMENT FLOOR PLAN

In the winter of 1918 their work was discovered in serious degree. At that time articles were being moved from one of the shelves in a store room in the basement of the administration building (Fig. 2, A.B.). As this task was in progress the partition to which the shelving was attached gave way. Some of the lath and plaster were removed, and it was found that the studding had been practically destroyed. The writers of this bulletin were then called into consultation and the work of eradication and control began.

Workmen employed by the hospital began tearing out the basement partitions. As this job proceeded, more and more evidence of the extensive mining that had been accomplished by the termites was laid bare. Practically all of the partitions in the main part of the basement of the administration building had been attacked. (Fig. 2, A. B. C. D. E. F. G. H.). A brick partition separated this part of the basement from the boiler room. (Fig. 2, I.) But in the boiler room planks used to enclose a coal bin were found infested. The supports of two stairways, leading into the basement (Fig. 2, F. H.), had been attacked.

The floor of the basement was cement. But the various wooden partitions had been built before the cement was poured. Therefore, the studding of the partitions was in direct contact with the sandy soil which underlies the basement. This may have furnished the means of entry by which the termites got into the basement, but of this no certain statement can be made. The basement floor is at a depth of four or more feet below the level of the ground outside. It may be that the termites burrowed beneath the basement wall and the cement floor and came up into the partitions, or it may be that they found access through some crack in the foundation walls where a partition was close by. In any event they had fairly riddled most of the partitions in this basement.

As the wood partitions were removed it was discovered that the insects had burrowed into some of the wood beams that support the floor timbers and the structure above. These wood beams rest on brick pillars. They are 10 x 12 inch timbers and for the most part are 18 feet in length. Two of these timbers had been so hollowed out by termites that they were structurally worthless.

FIG. 2. Basement plan of administration building showing the partitions as they were at the time the infestation was discovered.

All of the partitions and other material that had been taken out of the basement and first floor were burned. The spaces that were left in the concrete basement floor where the partitions had projected through to the ground beneath, were filled with cement so that the entire basement presented a continuous floor of concrete extending to the outer walls. The linings of hand holes were removed and burned.

Stairways were taken apart, or the lath and plaster removed far enough to disclose the upper limits to which the termites had mined. They were reconstructed so as to rest on the concrete floor. The infested boards in the boiler room were removed and burned.

It was necessary to remove two of the main supporting beams. In order to do this the central part of the building was supported with temporary timbers; the large beams—or what was left of them—were taken down from the brick pillars; and new beams were got into position by placing planks side by side vertically and bolting these together.

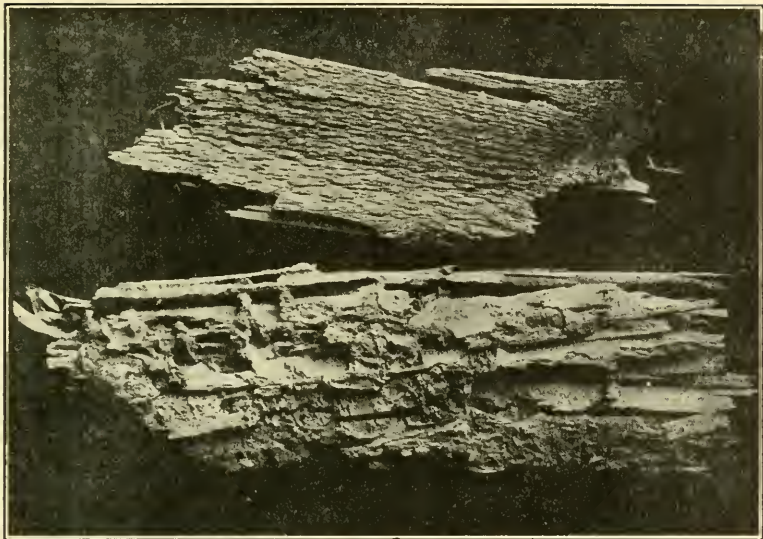
PLATE 1, A. At the top is a small section of a beam, showing surface apparently sound and giving no indication of the damage beneath. The lower piece shows galleries filled with frass.

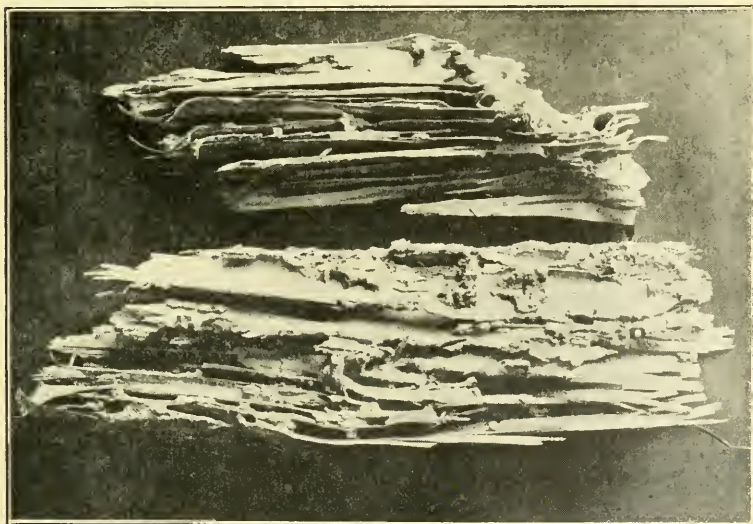
PLATE 1, B. Upper piece is the same section of wood as that shown at the top of Plate 1, A, but is the reversed side. Lower piece is the reverse of the lower one shown in Plate 1, A.

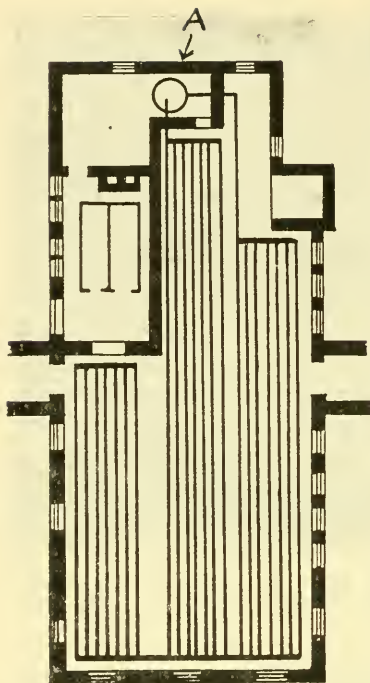
FIG. 4. Diagrammatic plan of supplementary heating coils installed in basement of administration building.

Following these preliminary tests, arrangements were made for installing supplementary steam pipes in the basement, of sufficient capacity to raise the temperature within the entire basement to 130° F. or more and to maintain it there.

In the rear of the basement was a small boiler capable of carrying a steam pressure of 50 lbs. or more, (Fig. 4, A.). A system of pipes was installed connecting with this boiler. Two inch pipes were used, arranged in three horizontal sections of seven pipes each. The pipes were supported on temporary brackets about 18 in. below the basement ceiling. They were arranged with only sufficient slope to drain off condensation. Each section extended the length of that part of the basement in which it was placed. The general arrangement of the system is shown in Fig. 4. The total amount of radiation surface was 700 feet, or about one foot to each 20 cubic feet of space in the basement.

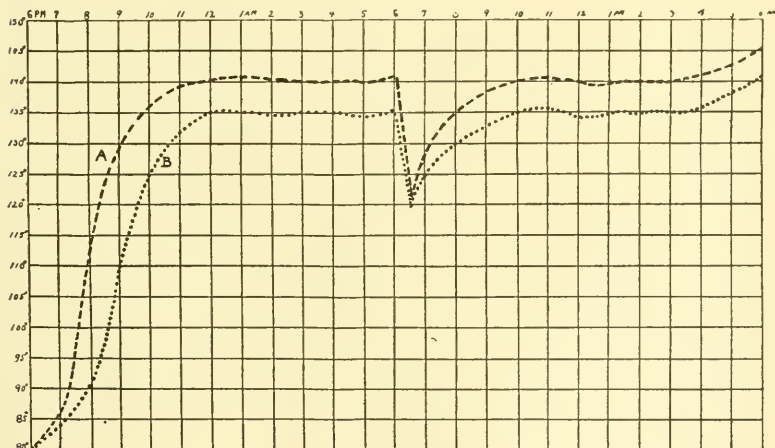
Within an hour after the heat was turned on the temperature began to rise, and this rise soon became rapid. By 9.30, or 3 1-2 hours after steam was admitted, the temperature in the upper part of the basement area had reached 120° F. Two hours later it had risen 15° further to 135° F. About six o'clock the following morning it was necessary to shut off steam, in order to make a slight repair to the boiler. The temperature in the basement promptly dropped to about 120° F. in the next 45 minutes, but when steam was turned on it rose fairly rapidly again and by ten o'clock had regained the high point of the earlier hours. At 4.00 p. m. the temperature began to rise still further and when heat was finally turned off at 6.00 p. m., 24 hours after the treatment started, the temperature had reached 140° F.

The readings of the five thermometers were averaged and have been reduced to a curve indicated by the dash line A in Fig. 5. The readings of the thermograph are indicated in the dotted line B of Fig. 5. It will be noted that the curve A runs higher than B, but it will be recalled that the thermometers from which the record A is taken were nearer to the basement ceiling than was the thermograph.

FIG. 5. Graph of temperature records. The dash line A is the average of thermometers lowered through floor. The dotted line B is the thermograph record.
